Manhole Inspection Summary

Manhole # S130__024MH

Insp Date: **3/25/08 9:30 AM**

Location Address: **361 Font Hill**

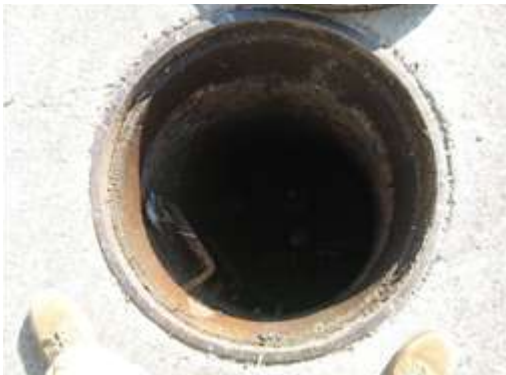
Defect 4

Frame Offset: **2** (in.) Condition: ☒ Sound ☐ Cracked ☐ Leaks

offset

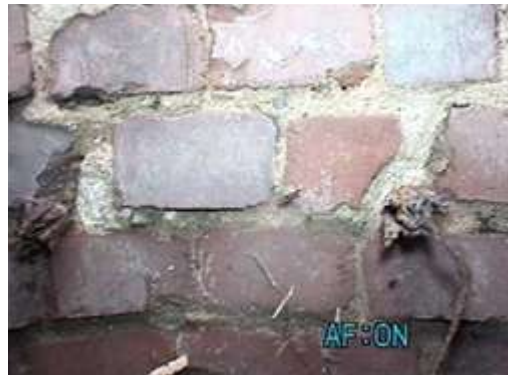
Defect 3

Steps Count: **6** Missing: **1** ☒ **Corroded**

missing of rung

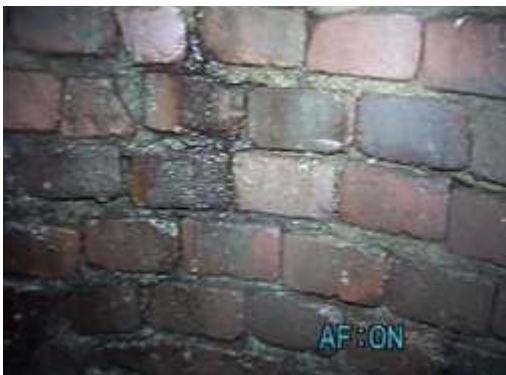
Defect 2

Infiltration: ☐ None ☐ Joint ☐ Cracks ☐ Mortar ☐ Roots ☒ **Wall**

signs of active infiltration barrel

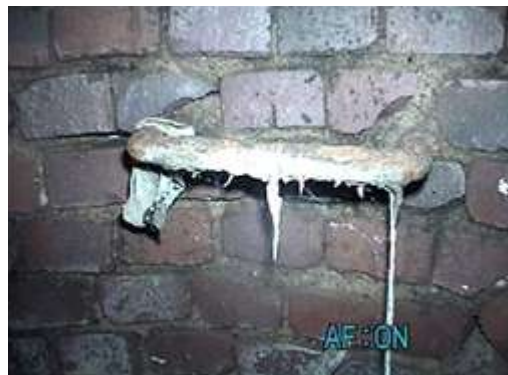
Defect 1

Surcharge ☒ **Evidence Of Surcharge** Depth: **3** (ft.) ☐ Active Surcharge Present

steps corroded, surcharge evidence
